MELODY LAKE DAM

FRANKLIN COUNTY, MISSOURI

PHASE 1 INSPECTION REPORT NATIONAL DAM SAFETY PROGRAM

PHASE I INSPECTION REPORT
NATIONAL DAM SAFETY PROGRAM

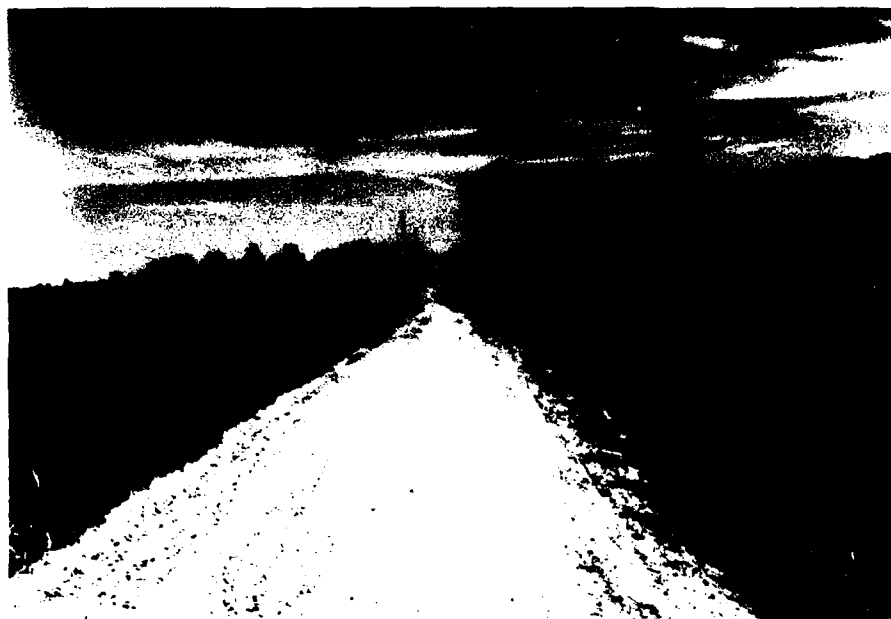
b. Dam. The visible portions of the upstream and downstream faces of the dam (see Photos 1 and 2) appeared to be in sound condition, although numerous trees and brush exist on the downstream side. Seepage, as evidenced by wet ground, cattails (see Photo 6) and flowing water, was noticed adjacent to the downstream toe of slope near the right abutment. Seepage was also noticed at the downstream toe of slope in an area between the left abutment and the spillway outlet pipe. Limestone riprap, ranging in size from 2 inches to pieces estimated to weigh about 200 pounds, serves to protect the upstream face of the dam above and below the normal waterline. A road with a gravel surface traverses the top of the dam crossing the crest of the emergency spillway. No cracking of the exposed ground surface at the crest was noticed. A profile along the top of the dam extending through the crest of the emergency spillway is shown on Plate 3. Examination of the top of dam profile indicates a difference of approximately 0.6-foot between low and high elevations. It is probable that settlement, due to thawing and subsequent consolidation of frozen fill (see discussion in paragraph 2.2), could account for the irregular level of the top of the dam.

NO. 1: CREST AND UPSTREAM FACE OF DAM

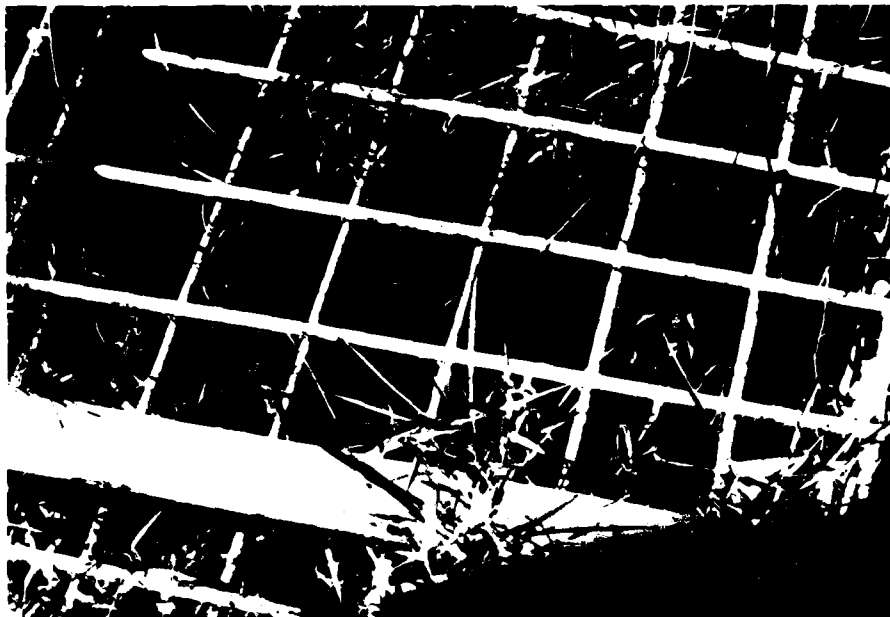
c. Drop Inlet Spillway. The 18-inch diameter steel pipe riser section for the drop inlet type spillway (see Photo 3), located near the center of the dam, appeared to be in good condition. A steel bar trash screen serves to protect the opening from clogging by debris. The screen also appeared to be in good condition. On the day of inspection, the lake level was approximately 2 - 3 inches below the top of the riser. The growth of grass around the riser indicates that the normal pool level has not been maintained for some period prior to the inspection. The visible part of the end of the 12-inch diameter steel pipe outlet for the drop inlet spillway appeared to be in satisfactory condition, although it did have a coating of rust. A profile of the drop inlet spillway is shown on Plate 4. The profile of the 12-inch line is assumed based upon the invert elevations measured at the upper and lower ends of the pipe. The channel subgrade at the 12-inch pipe outlet was eroded and filled with water (see Photo 5). Several medium-size willow trees were growing in the channel in the vicinity of the outlet pipe (see Photo 4). The downstream channel below the outlet pipe is unimproved and joins the Bourbeuse River approximately 2,000 feet below the dam. The channel lies adjacent to the lagoon dike for a distance of about 600 feet.

NO. 3: 18-INCH DROP INLET SPILLWAY
